BIRDSBORO RESERVOIR

PHASE I INSPECTION REPORT NATIONAL DAM INSPECTION PROGRAM

SEPTEMBER 1978

BIRDSBORO RESERVOIR
BERKS COUNTY, PENNSYLVANIA
NATIONAL I.D. NO. PA 00713

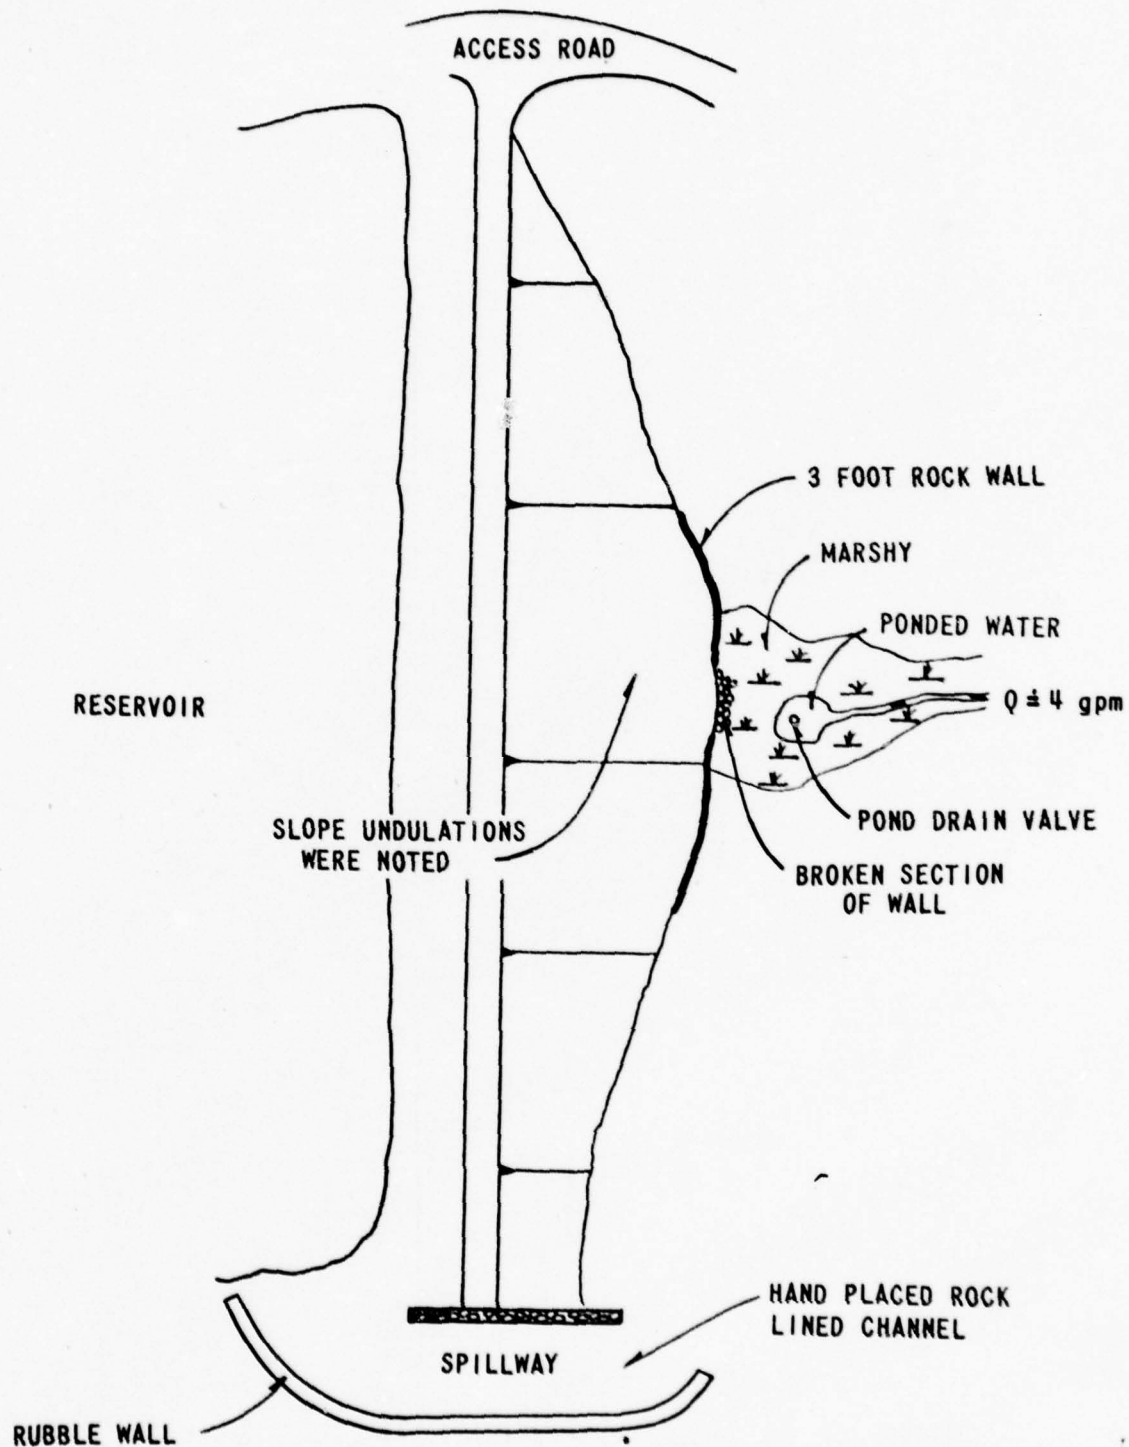
SHEET 5a OF 11

An area as shown on sheet 5a is marshy and contains standing water. Seepage flow was judged to be on the order of four to five gpm. The pond drain valve stem was located at the base of the dam in the marshy area. As discussed on sheet 4, dampness was noted on the downstream slope of the embankment.

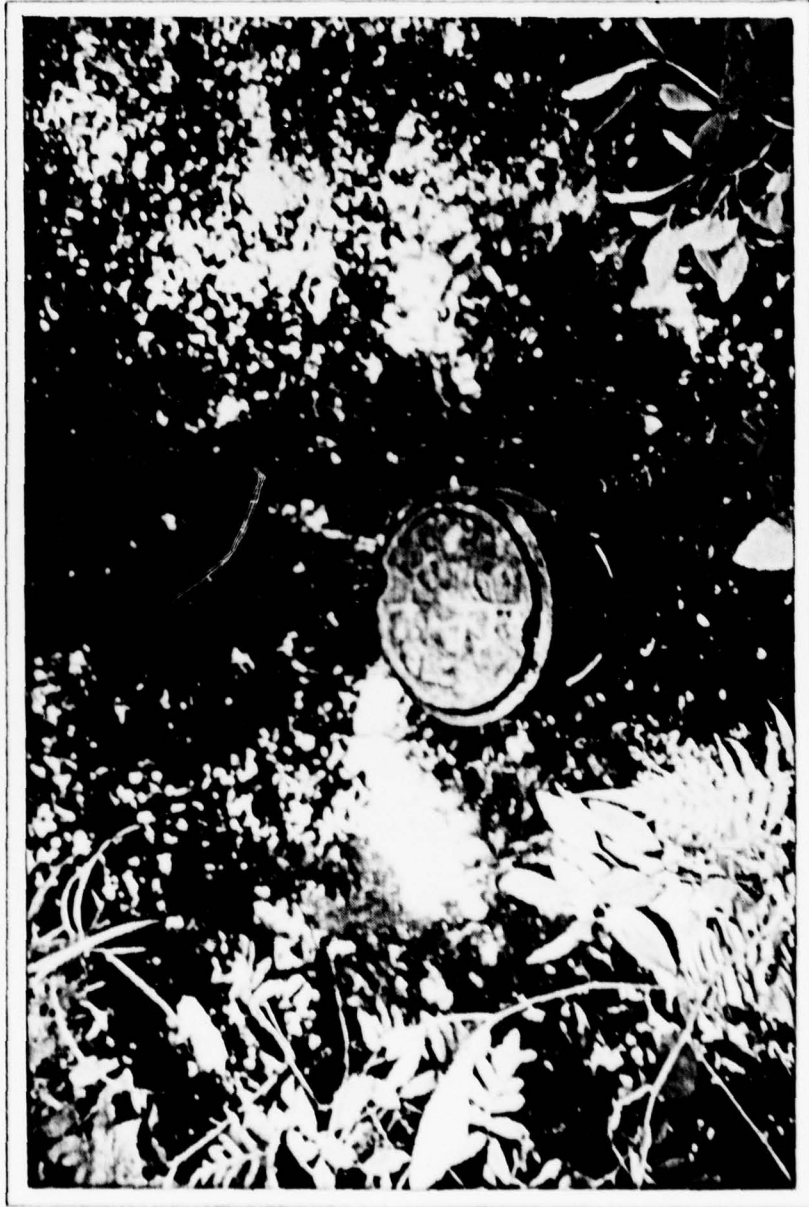
POND DRAIN VALVE LOCATED IN POOL OF
WATER JUST BEYOND DOWNSTREAM TOE.
SEE SHEET 5a, APPENDIX B.

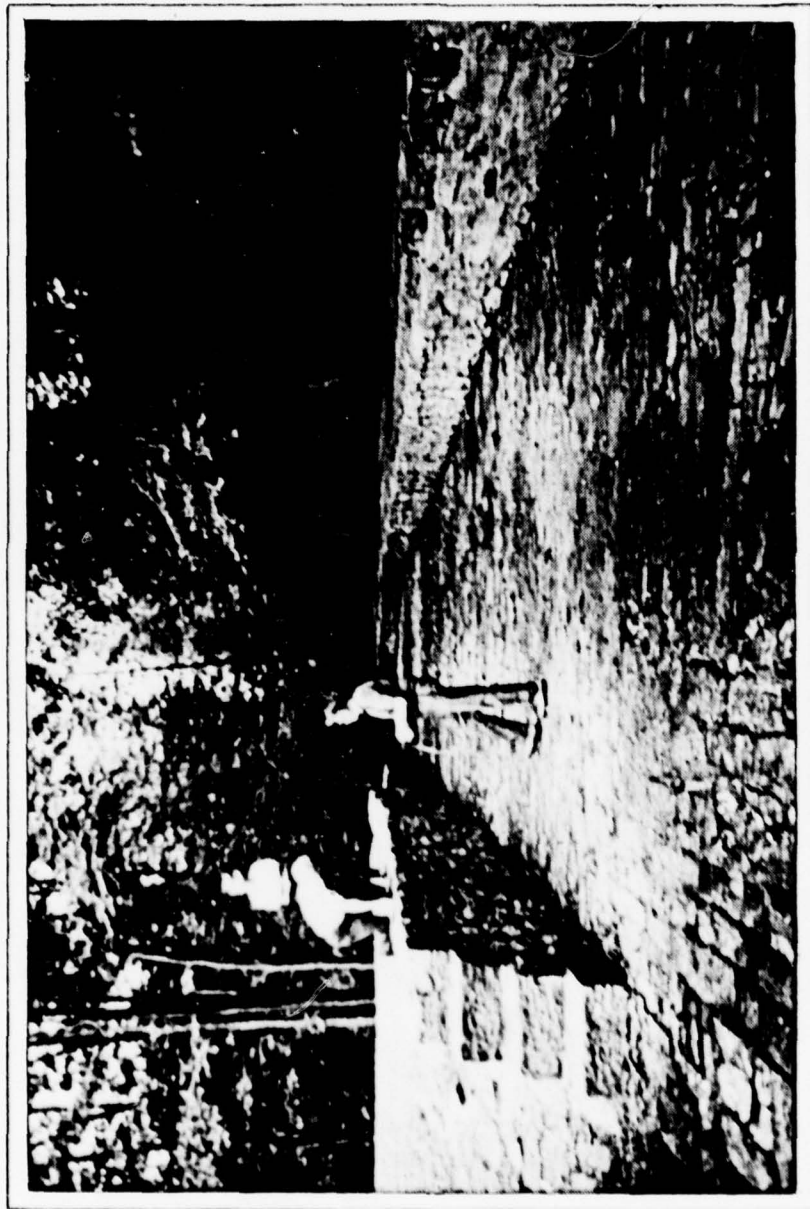
LOOKING DOWNSTREAM OF THE SPILLWAY
CHANNEL.

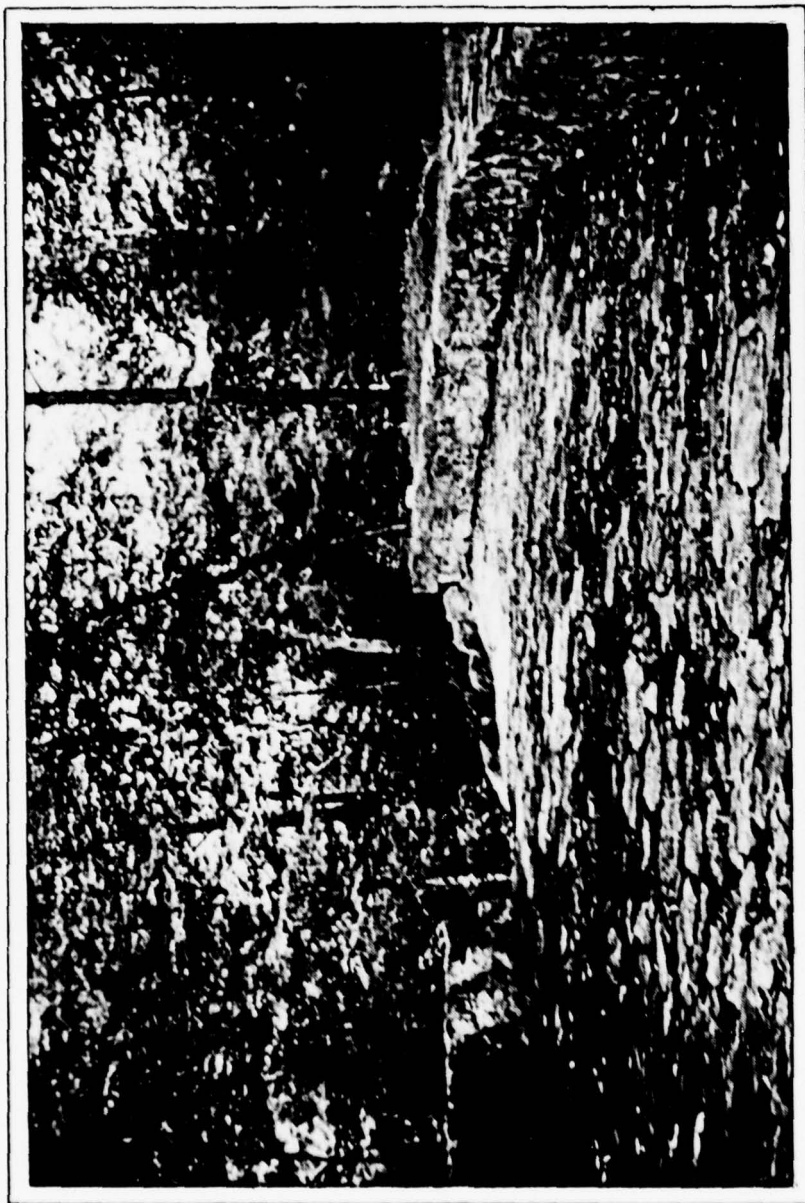
PHOTOGRAPH NO. 6

DISCHARGE CHANNEL	The hand placed rock channel is in good condition. The end of the channel was damaged during Tropical Storm Agnes (June 1972) and was repaired using concrete in lieu of the hand placed rock. Currently, discharge passes along the left side of the channel where minor erosion is occurring. This area should be inspected after severe storms.	
-------------------	--	--

SPILLWAY EXIT INTO THE NATURAL STREAM
CHANNEL. LOWER SECTION OF SPILLWAY
WAS RECONSTRUCTED WITH CONCRETE AFTER
BEING DAMAGED BY TROPICAL STORM AGNES,
JUNE 1972.

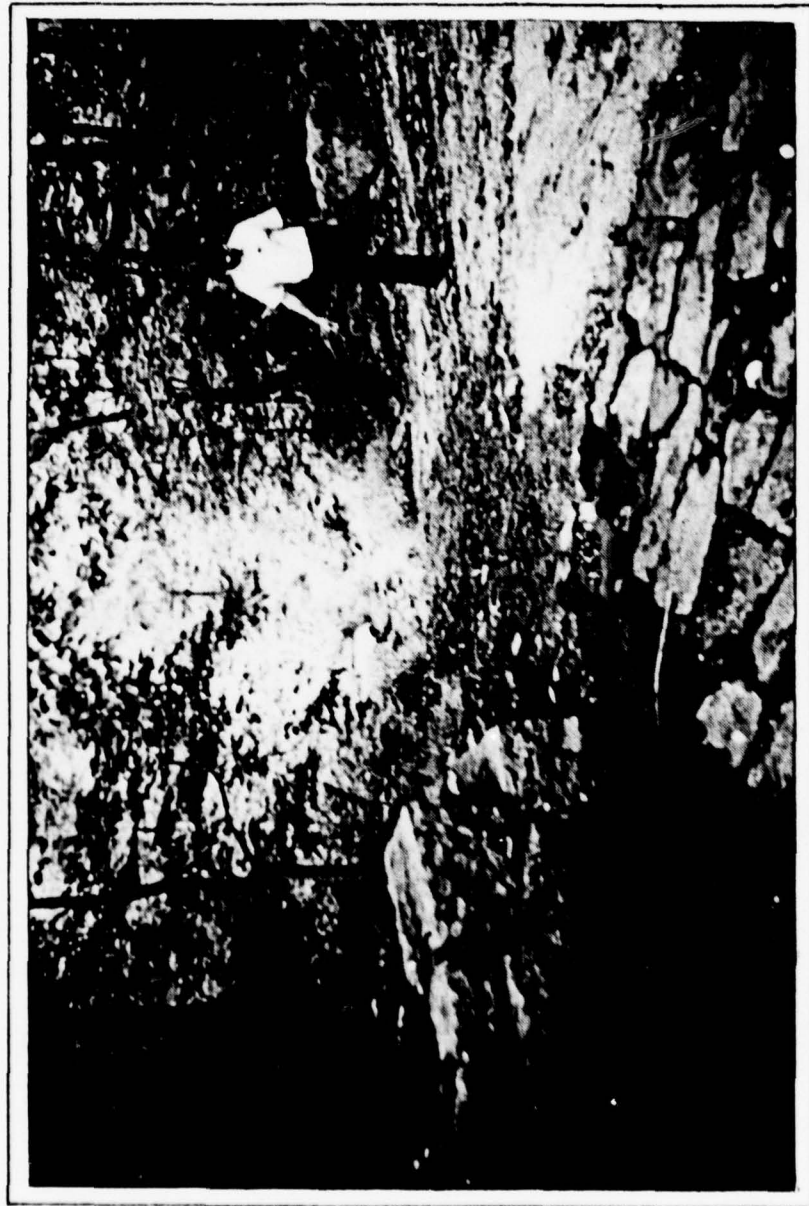
REFERENCE INFORMATION ON PHOTOGRAPH
NUMBER 6. NOTE CONCRETE REPAIRS.

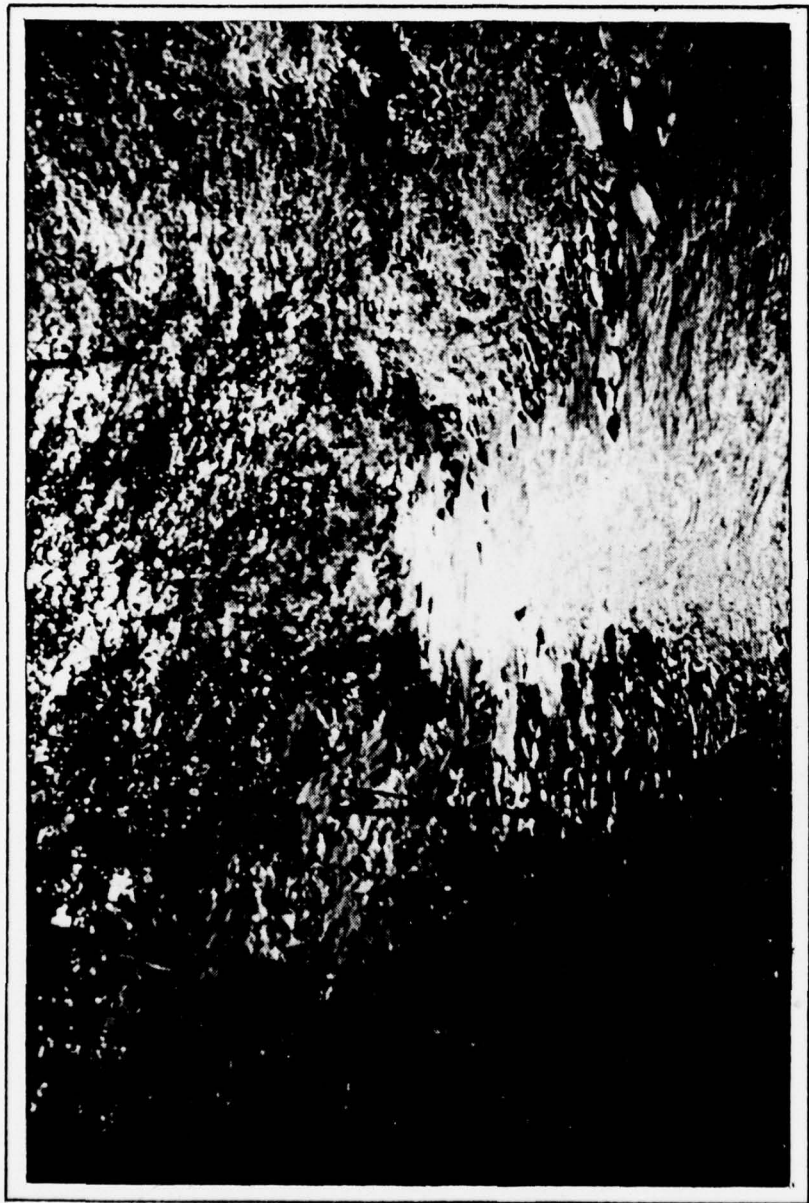
PHOTOGRAPH NO. 12

TYPICAL VIEW OF DOWNSTREAM CHANNEL.
